# dsPIC33EPXXXGP50X, dsPIC33EPXXXMC20X/50X and PIC24EPXXXGP/MC20X

## dsPIC33EPXXXGP50X, dsPIC33EPXXXMC20X/50X and PIC24EPXXXGP/MC20X Family Silicon Errata and Data Sheet Clarification

The dsPIC33EPXXXGP50X, dsPIC33EPXXXMC20X/50X and PIC24EPXXXGP/MC20X family devices that you have received conform functionally to the current Device Data Sheet (DS70657E), except for the anomalies described in this document.

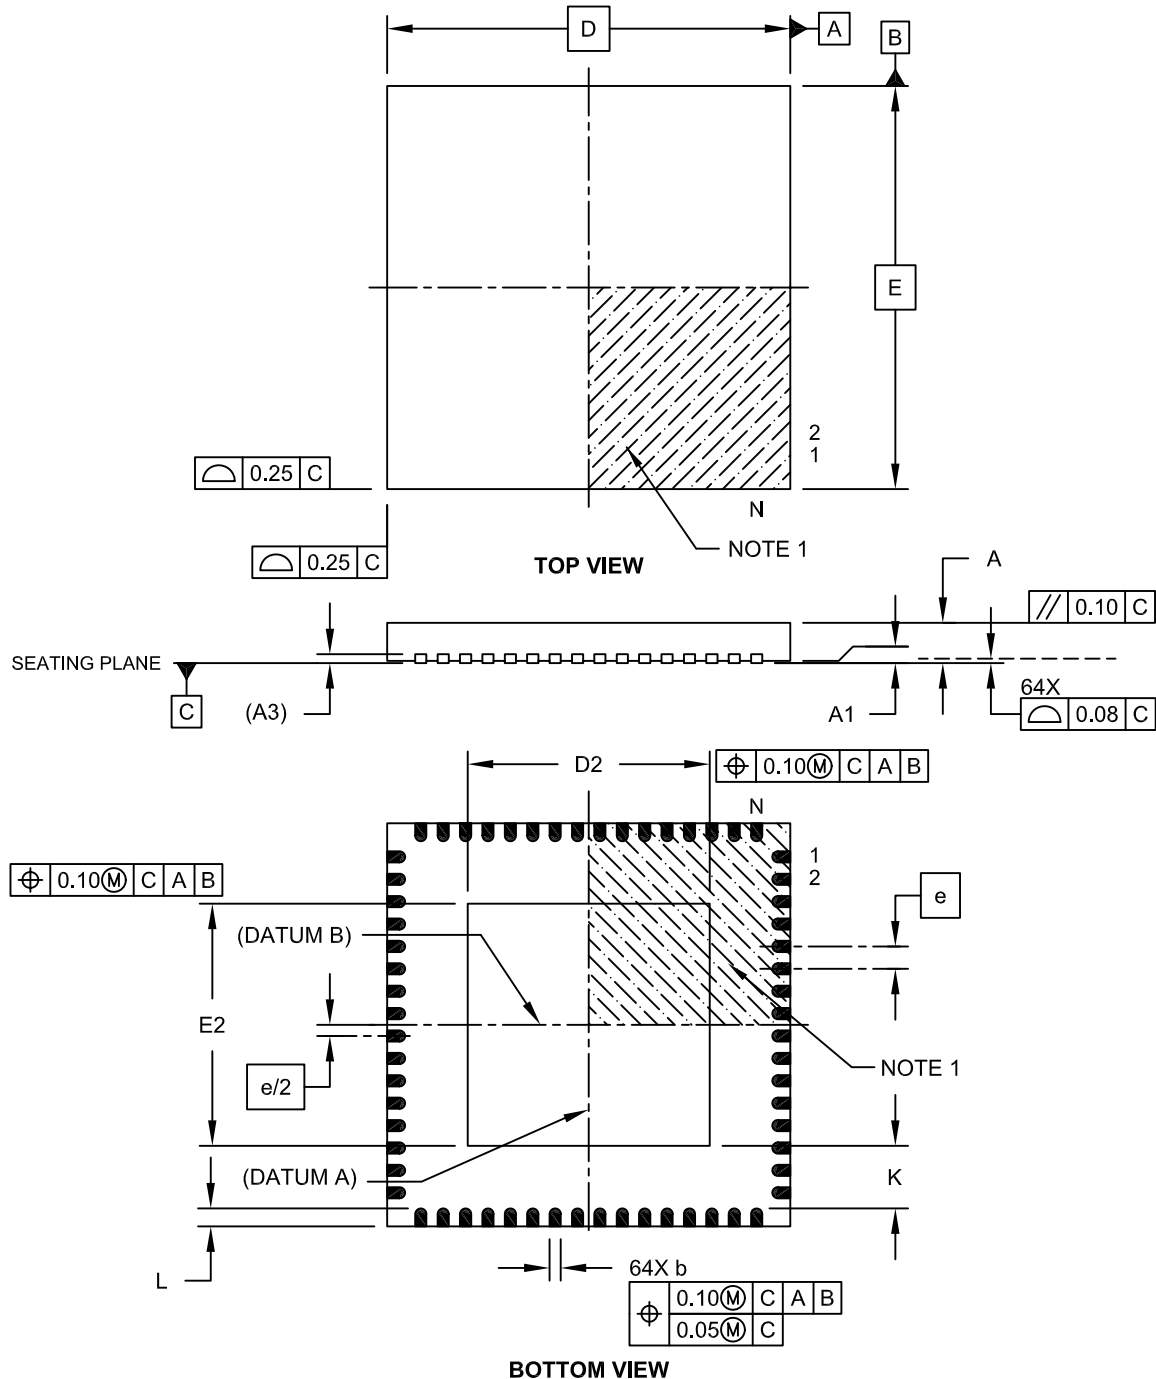
Microchip Technology Drawing C04-154A Sheet 1 of 2

**64-Lead Plastic Quad Flat, No Lead Package (MR) – 9x9x0.9 mm Body  
with 5.40 x 5.40 Exposed Pad [QFN]**

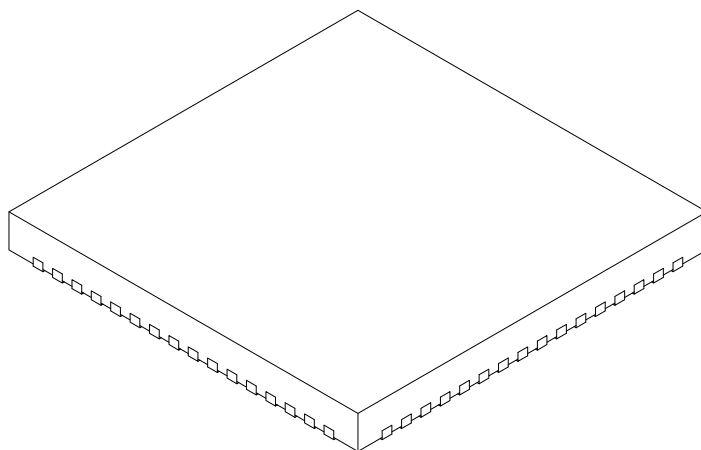
**64-Lead Plastic Quad Flat, No Lead Package (MR) – 9x9x0.9 mm Body with 5.40 x 5.40 Exposed Pad [QFN]**
